Manhole Inspection Summary

Manhole # S25AA2003MH

Inspection ☐ Is Incomplete Rating: **4) Poor**

Location Address: **800 NORMANDY PL**

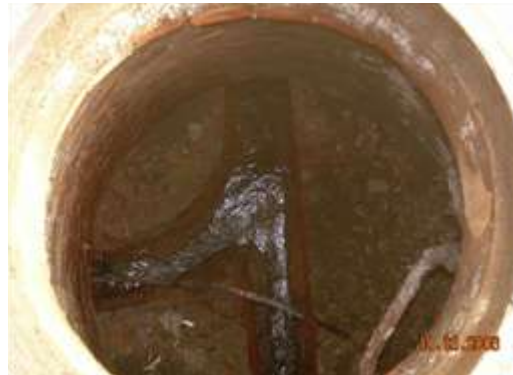
Top View

Corroded steps. Barrel infiltration.
Evidence of surcharge - Bench debris.

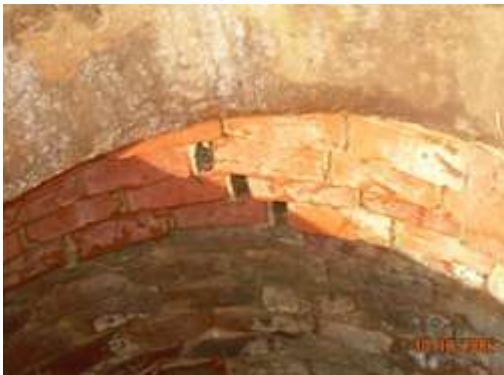
Defect

Corbel cracks, loose brick and infiltration.
Barrel infiltration.

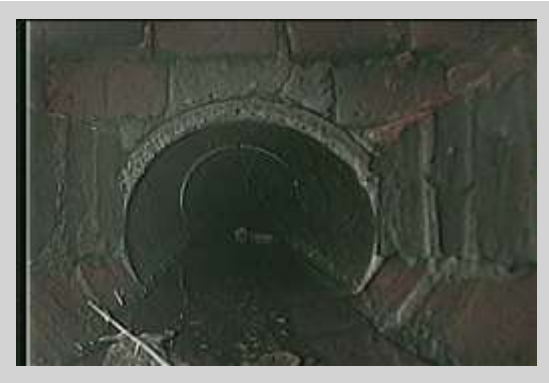
8 in. Circular Gravity Sewer Pipe Out @ 12 O'Clock

Barrel deterioration and infiltration.

Deposits: ☐ None ☒ **Mud** ☐ Sludge ☒ **Debris** ☐ Grease

Infiltration: **Evidence** Pipe Seal Cond: **Unknown**

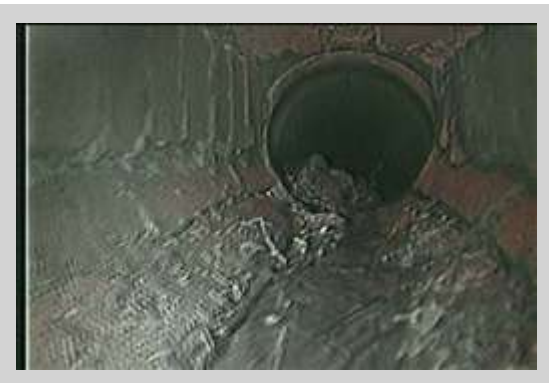
8 in. Circular Gravity Sewer Pipe In @ 6 O'Clock

Channel deterioration.

Deposits: ☐ None ☐ Mud ☐ Sludge ☒ **Debris** ☐ Grease

Infiltration: **Evidence** Pipe Seal Cond: **Unknown**

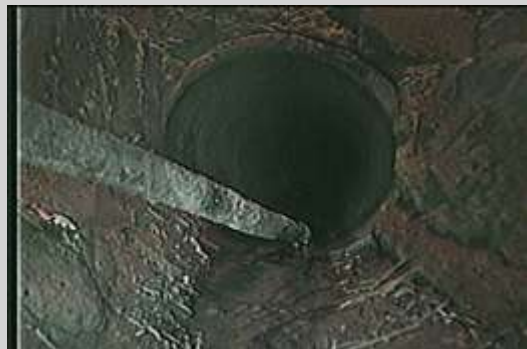
Pipe In @ 9 O'Clock

Infiltration: **Evidence**
